# Road Safety Analysis at Intersections: Case of the North Entrance of Porto Nacional - TO

**Abstract**— The present work aims to analyze the efficiency of the intersection located at the TO - 050 at the entrance of the city of Porto Nacional - TO, the chosen location presents negative points regarding the safety of the drivers, due to the connection of the expressway with highways. Without the addition of auxiliary lanes and poor signage, generating dangerous intersections and overtaking, and the existence of the entrance port of the municipality at the intersection that impairs the visibility of drivers. The region has large movement of cargo and passenger vehicles due to agricultural production and because it is the connecting section of the capital of the state of Tocantins (Palmas) with the municipality of Porto Nacional, consequently increasing the likelihood of accidents on the site. Therefore, the need to study conflict points and their origins is identified, guaranteeing efficient traffic flow and safety for drivers.

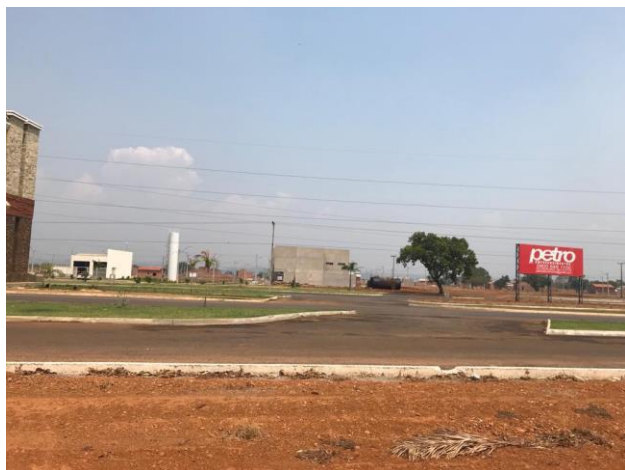
Fig. 3: Conflict Points.

Fig. 3 shows the actual signaling situation at two of the conflict points, noting the absence of mandatory stop signs and horizontal signaling.

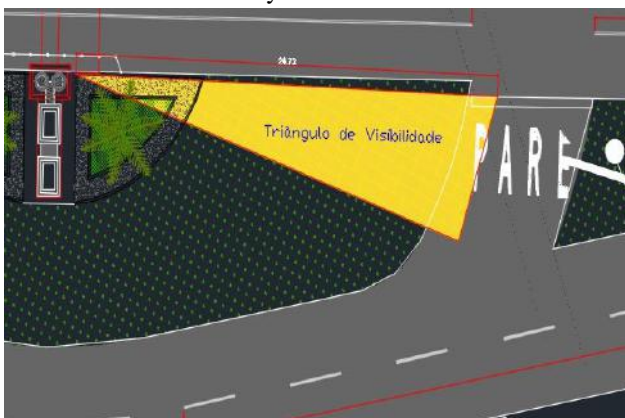
Fig. 4: East Visibility Triangle of the Temporary Signaling Project.

Fig. 4 shows a point of conflict where we established the east visibility triangle, when checking it noted that the North Portal interferes with driver visibility, this interference can aggravate accidents at that location, as it is an intersection for entry into an allotment.

One of the most alarming points of this project is the visibility of the drivers, they are impaired by the existence of the North Portal, it is within the visibility triangle and the intersection is close to a curve, with this dimensioning the driver ends up having a minor reaction, with the possibility of lateral collisions, and the intersection has virtually no signaling or speed reducers, as shown in Table 9 .
